THE SENSOR SPECIALIST

PARTSMARTS

Knock Sensor Corrosion Prevention

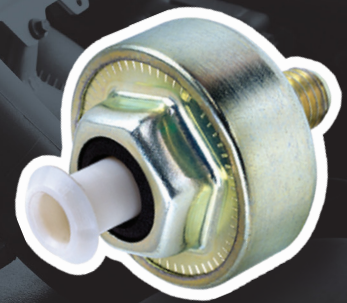
KNOCK SENSOR CAN FAIL DUE TO HEAT AND MOISTURE BUILD-UP.

Due to the location of the OE knock sensor (part number 10456603) and its connector, excessive heat and moisture can cause corrosion, which leads to part failure. This condition commonly produces an engine ping and check engine light with trouble code P0332 (Knock Sensor Circuit Low Frequency).

To address the engine ping condition, trouble code, and corrosion issue, replace knock sensor with **NTK part number ID0116** and electrical connector with **WVE part number 1P1031**.

To prevent future issues, build a circular dam (wall) around the sensor using silicon. While creating this wall, be sure to leave a small gap at the rear. This wall will divert water away from the sensor, while leaving an exit point for the moisture that does accumulate. Performing this repair properly will prevent future failures from occurring. *NTK is The Sensor Specialist™.*
