PARTSMARTS Insight and intelligence from The Ignition Specialist[™]

U5121 Ignition Solution for CHRYSLER, DODGE, RAM and JEEP Coil corrosion

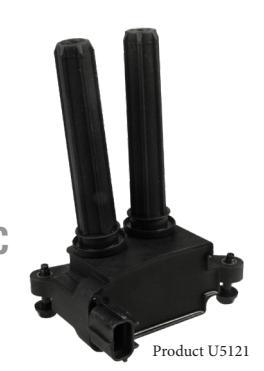
Figure 3: Brass terminal connection with dielectric grease at 20x magnification.

Figure 4: Brass terminal connection with dielectric grease at 50x magnification.

THE SOLUTION BRASS SECONDARY WINDING TERMINAL CONNECTIONS AND INSULATING DIELECTRIC GREASE REDUCES CORROSION.

NGK utilizes an anti-corrosive brass terminal connection insulated with dielectric grease to reduce corrosion (Figures 3–4 below). In turn, this optimizes engine performance and can improve fuel economy up to 20%, which can yield an additional 4-6 mpg. *NGK is the Ignition Specialist.*
